Underwater inspection of trade-yards

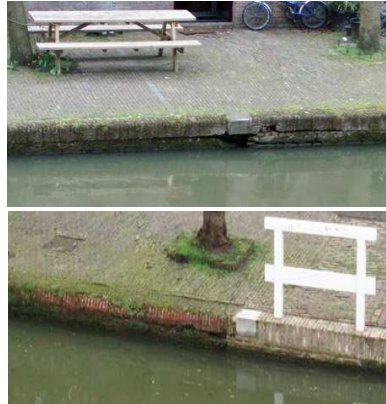
<p><i>Severe damage in walls and bricks at the Utrechts trade-yards</i></p>	<p><i>Monitor on trolley</i></p>	<p><i>Camera with measuring window on a stick</i></p>

Since 1950 the old trade-yards and storage vaults have been renovated and sealed against penetrating water. From that time they are commercially used and have become a major tourist attraction. There's a danger of decline, coming from below the waterline. One can see long cracks in the brickwork. Some of those cracks are a few metres long. Masonry is severely damaged and bricks disappear from the walls. And this is just what you can see.
