## Observation at a heat of 300 degrees

**A water cooled inspection system detects any leakage under a steam injected turbine. Detection is performed at a temperature of 300 degrees and tremendous noise. No job for humans, the right job for a camera.**

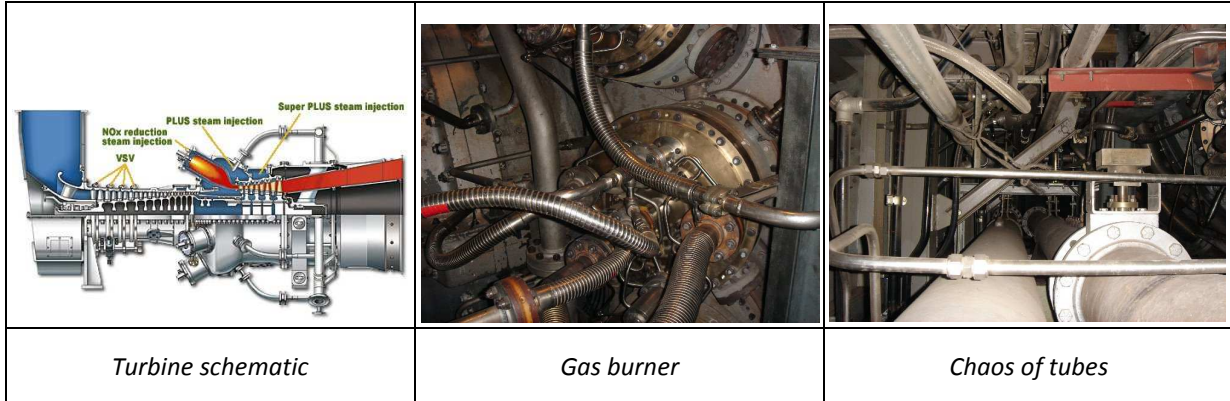
Camtronics has developed a water cooled camera system to detect waterdrops etc. under the gas burners. In this way it is possible to interfere at once without shutting down the plant. A remarkable and unique job if you see the chaos of pipe-work and wiring (see pictures on the right) where under, behind and above inspection has to take place. Moreover local temperatures are 300 degrees C and there is a tremendous noise. No job for humans, the right job for a camera and a good point for the environment.
